DEPARTMENT OF TRANSPORTATION

Quality Assurance and Source Inspection

Contract #: 04-0120F4Cty: SF/ALA Rte: 80 PM: 13.2/13.9File #: 69.28**WELDING INSPECTION REPORT****Resident Engineer:** Siegenthaler, Peter**Address:** 333 Burma Road**City:** Oakland, CA 94607**Report No:** WIR-020258**Date Inspected:** 06-Oct-2010**Project Name:** SAS Superstructure**OSM Arrival Time:** 700**Prime Contractor:** American Bridge/Fluor Enterprises, a JV**OSM Departure Time:** 1900**Contractor:** Zhenhua Port Machinery Company, Ltd (ZPMC), Changxing Island **Location:** Shanghai, China**CWI Name:** Yu Dong Ping, Qiu Wen**CWI Present:** Yes No**Inspected CWI report:** Yes No N/A**Rod Oven in Use:** Yes No N/A**Electrode to specification:** Yes No N/A**Weld Procedures Followed:** Yes No N/A**Qualified Welders:** Yes No N/A**Verified Joint Fit-up:** Yes No N/A**Approved Drawings:** Yes No N/A**Approved WPS:** Yes No N/A**Delayed / Cancelled:** Yes No N/A**Bridge No:** 34-0006**Component:** OBG/TOWER**Summary of Items Observed:**

BAY 11, OBG BIKE PATH (NWIT # 06873)

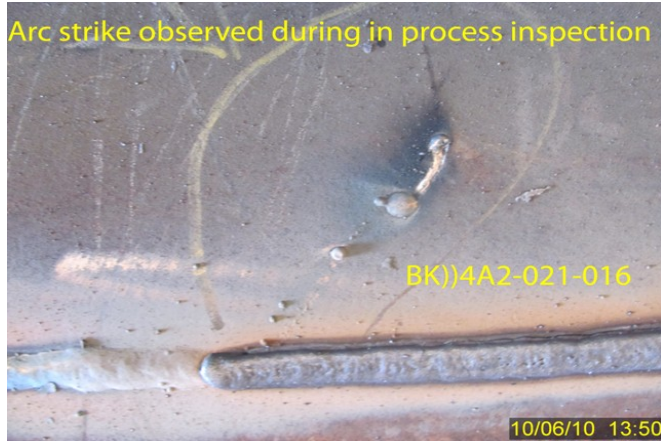
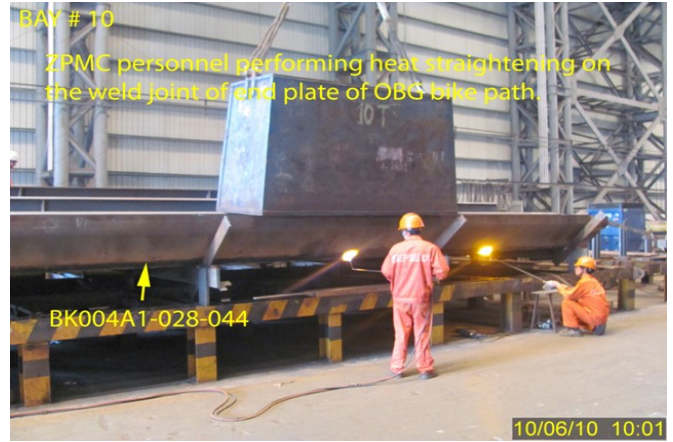
During random in process inspection of Orthotropic Box Girder (OBG) member identified as bottom cover plate this QA observed an arc strike on Piece Mark (PCMK) identified as BK004A2-021-016. This QA marked the affected area and informed ZPMC Quality Control (QC) identified as Miss Yu Dong Ping of this issue. Miss Yu Dong Ping informed this QA that the arc strike would be corrected in a manner compliant with the contract documents.
